TECHNICAL NOTE 2920

INTERIM REPORT ON A FATIGUE INVESTIGATION OF A  
FULL-SCALE TRANSPORT AIRCRAFT WING STRUCTURE

By M. James McGuigan, Jr.

April 1953

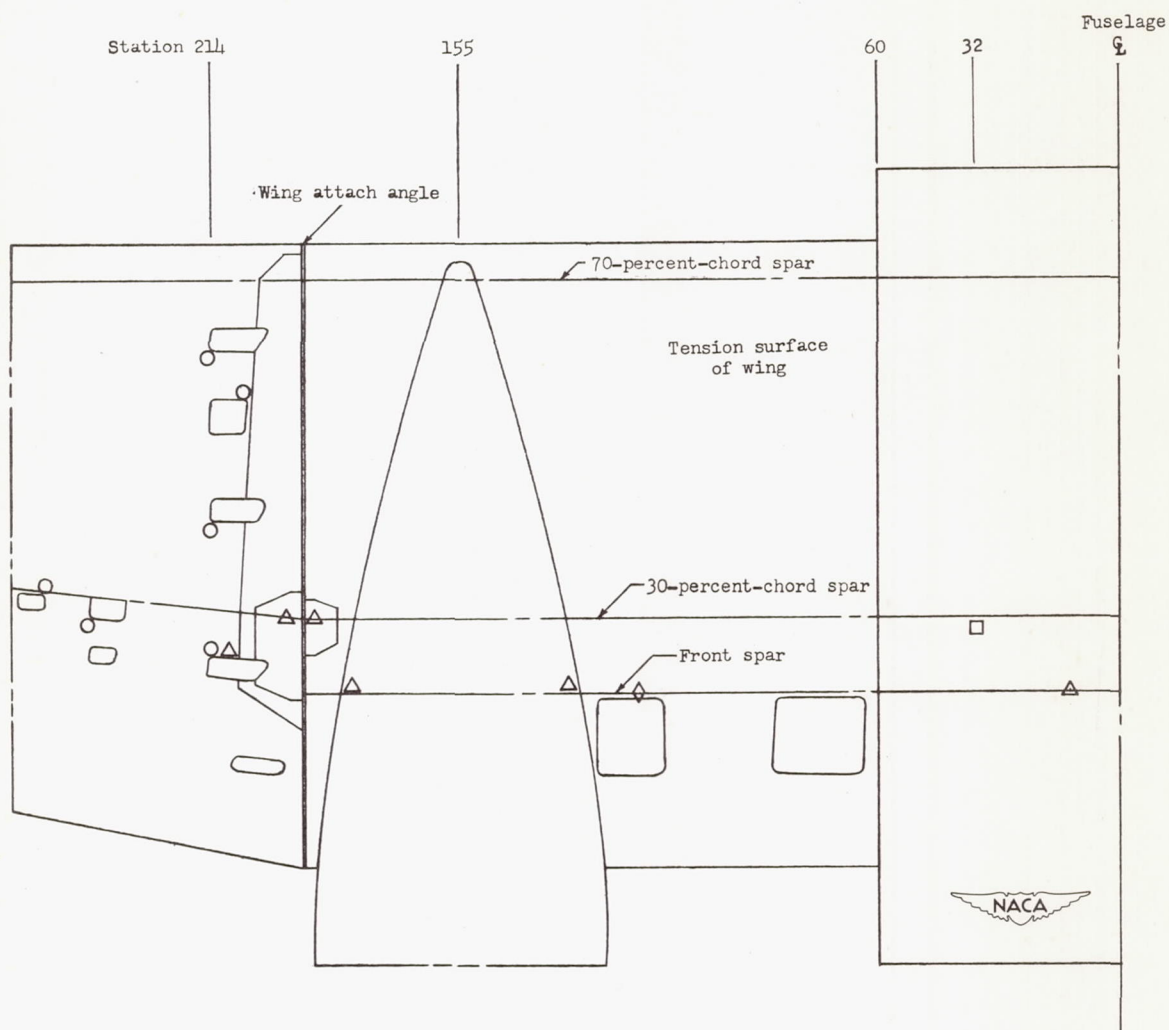
The first type included the 10 failures which originated at the corners of inspection cutouts. The second type included the 6 failures which occurred in a riveted tension joint near the center line of the aircraft. The third type included the 6 failures which occurred in a riveted shear joint where the shear web of the front spar was riveted to the tension flange of that spar. The fourth type included 12 failures which originated at abrupt changes or discontinuities in section or shape, such as the edge of a reinforcing doubler plate. The points of initiation for these four types of failure are shown in figure 7 which is a plan view of the tension surface of the wing. For convenience, failures that occurred on both wings are shown on a portion of one semispan.

- Type I      Failures originating at the corners of inspection cutouts
- Type II      Failures originating in riveted tension joints
- ◇ Type III      Failures originating in riveted shear joints
- △ Type IV      Failures originating in section at geometrical discontinuities

Figure 7.- Location and types of fatigue failures.

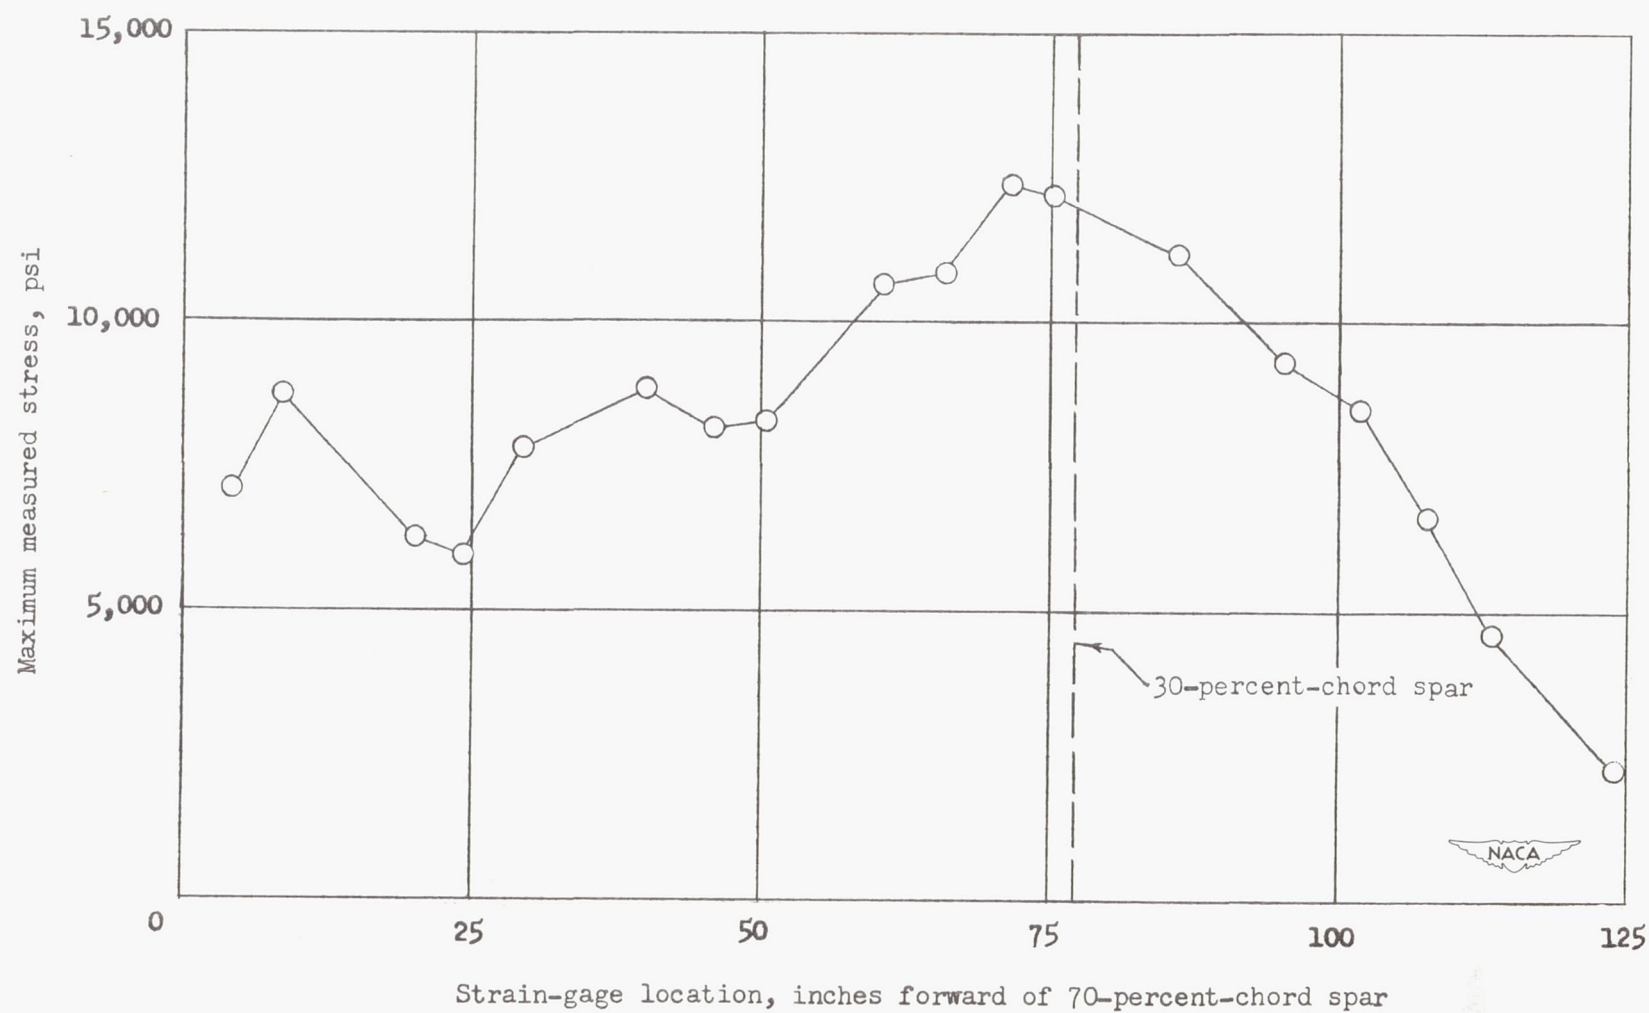
Figure 8.- Chordwise distribution of 1.625g measured stress at station 214.

The failures of type I, which occurred at the corners of inspection cutouts, all originated on the outer panels in the vicinity of span station 214. The chordwise distribution of stress through this section, as measured with strain gages, is shown in figure 8. Failure 3, which is a typical example of this type of failure, is shown in figure 9(a) a short time after starting and again in figure 9(b) after it had progressed to a length of about 17 inches. In figure 9(c) the same crack is shown after causing failure of the spar at the 30-percent-chord position. Another failure of this type is shown in figure 10. The crack originated at the cutout nearest the rear spar at span station 214 and was repeated more often than any other failure of this type. It appeared on all three left wings and on the third right wing. In no case, however, did this crack result in final failure of the wing. The failures originating in this identical location were failures 5, 17, and 33 on the left wing and 26 on the right wing. Failures occurring at the same locations on the left and right wings will be considered as identical for purposes of further discussion.

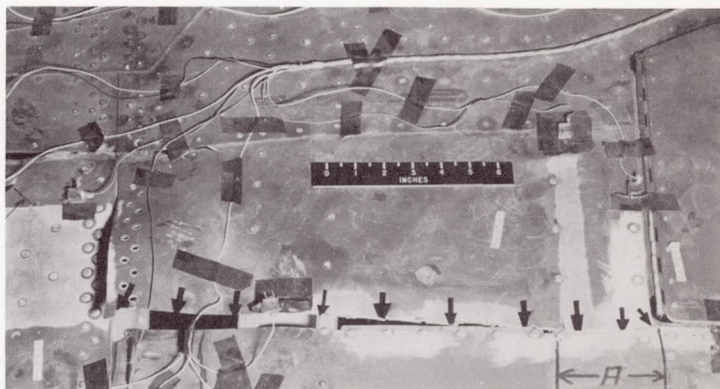
Although the corners of most of the inspection cutouts have fairly large radii, the corners of some of the reinforcing doubler plates underneath the cutouts have much smaller radii. This situation caused the initiation of some failures in the doubler plates which in one case progressed into the wing skin. An example of the start of one of these failures is shown in figure 11.

(a) Start of failure.

(b) Intermediate stage of failure.

(c) Final stage showing failure of 30-percent-chord spar.

Figure 9.- Three stages of typical failure that originated at corner of inspection cutout.

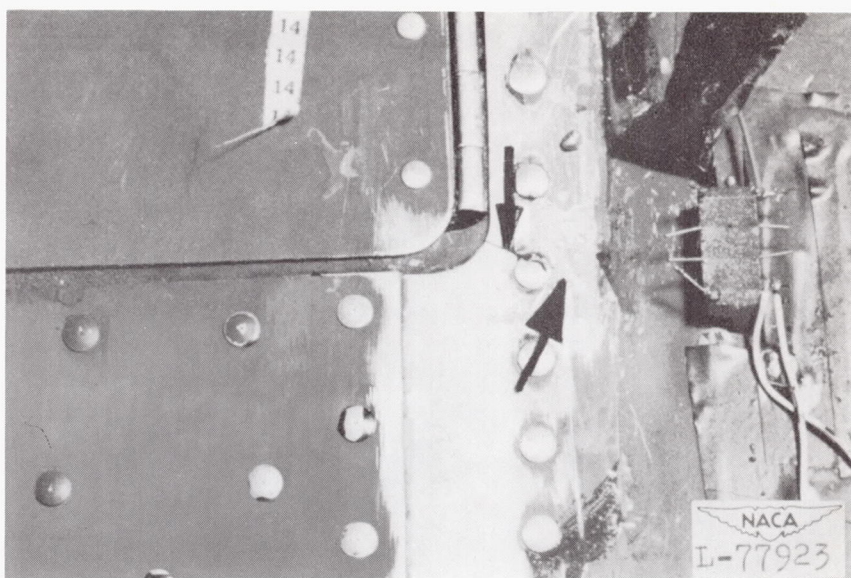
Figure 10.- Typical example of consistent failure that originated at corner of inspection cutout.

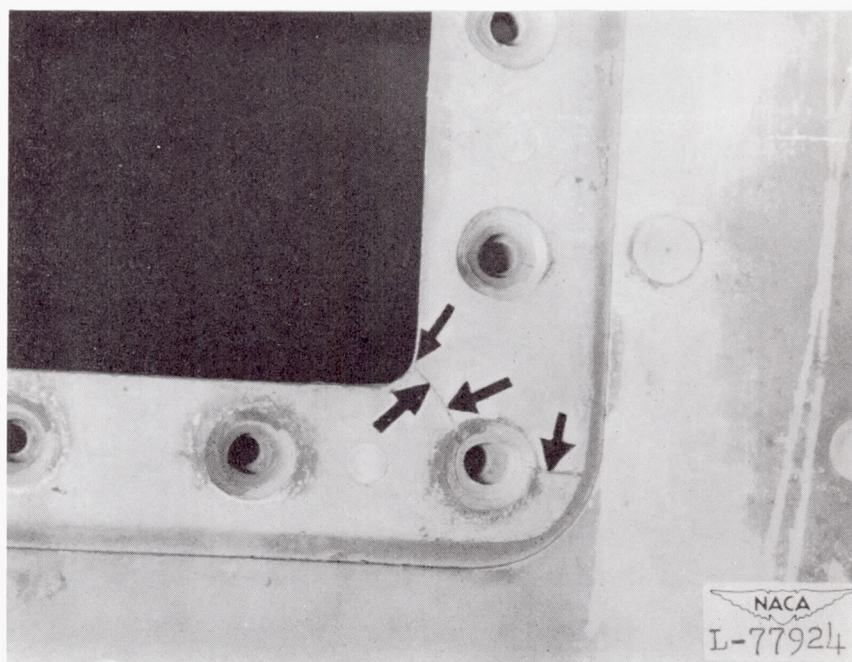
Figure 11.- Failure that originated in sharp corner radius of an internal reinforcing doubler plate.

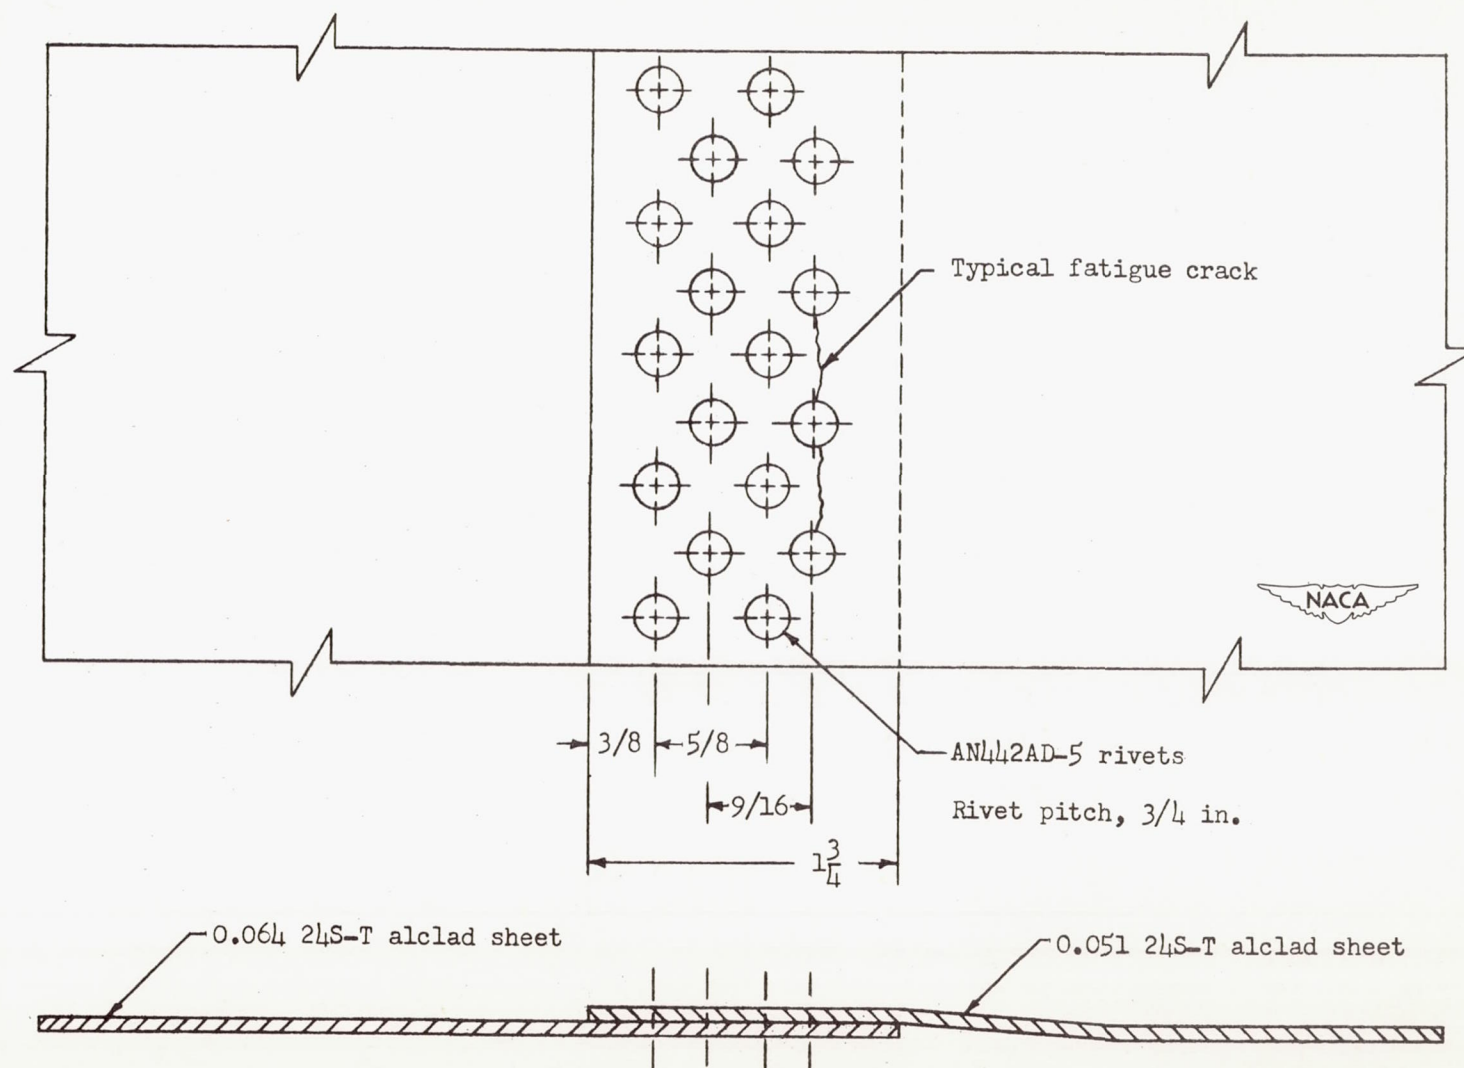
The second type of failure occurred in a riveted tension joint 32 inches from the aircraft center line. The joint extended chordwise at this wing station from the front spar to the rear spar. Failures of this type appeared on the left and right wing of the first three wing center sections in the same chordwise location and are listed as failures 1, 2, 11, 14, 22, and 23. The details of this joint and the manner of failure are shown in figure 12. The measured chordwise stress distribution through this section is shown in figure 13, from which it may be seen that the highest stress occurs at the point where all the failures originated.

Figure 12.- Details of riveted tension joint at span station 32. All dimensions are in inches.

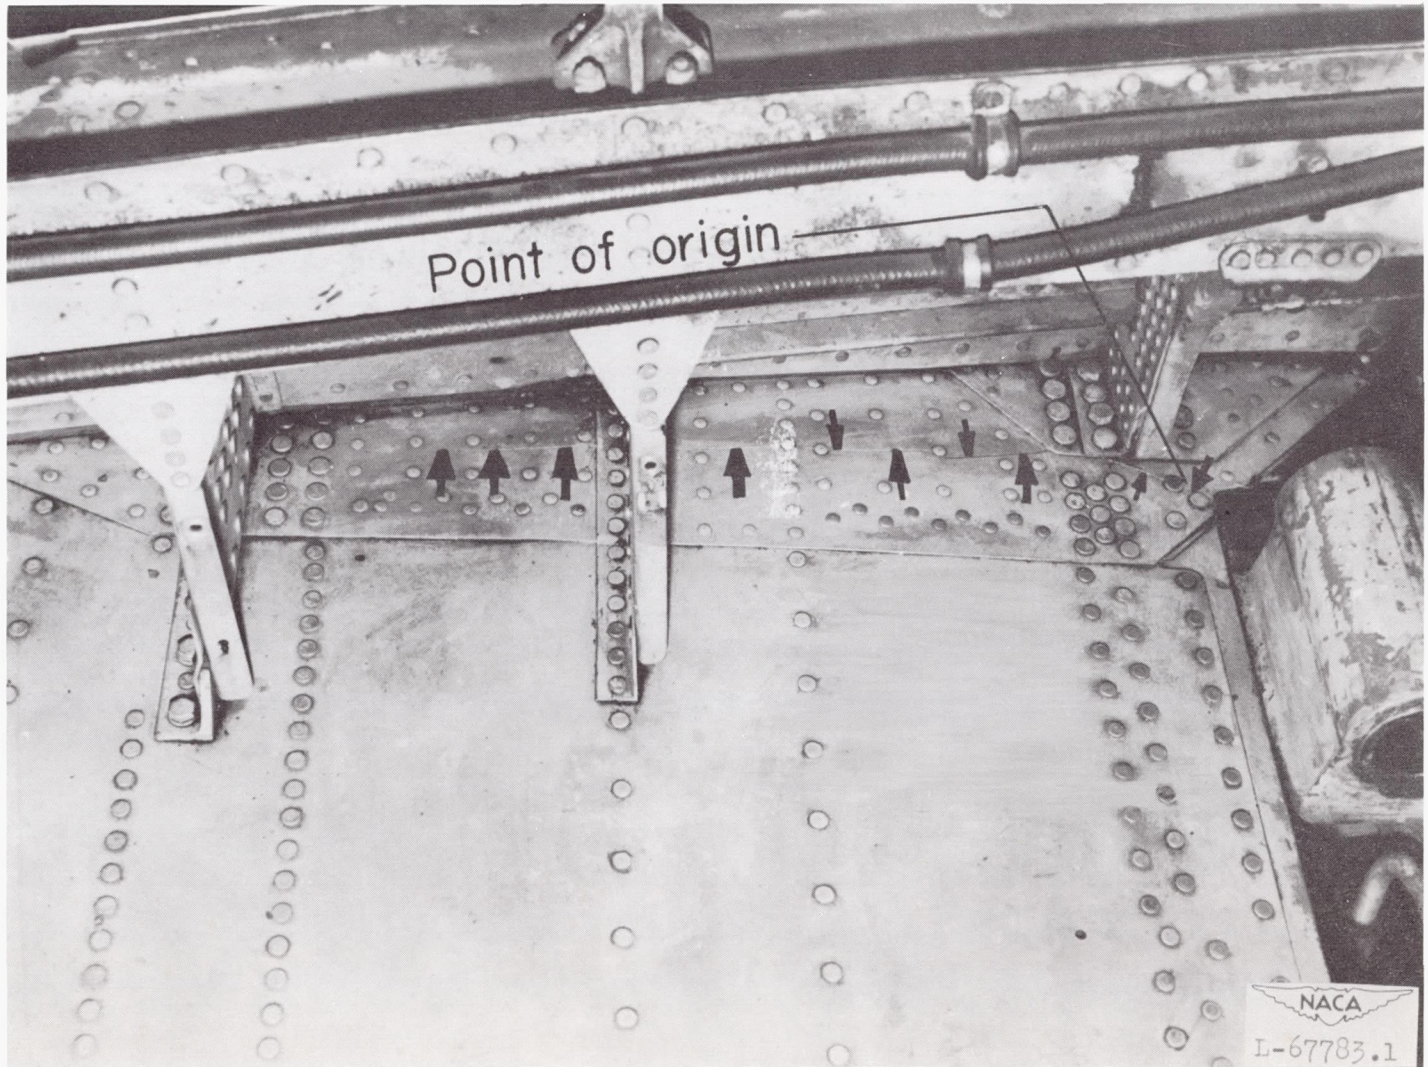
A typical example of those cracks which occurred at the junction of the engine nacelle and the wing spar and which are grouped in the fourth type is shown in figure 15. The failure shown is similar to failures 6, 7, 18, 19, and 30 and originated in a rivet hole near a half-round notch cut in the edge of the skin to eliminate interference of the landing-gear retracting strut with the wing skin during operation of the landing gear. Another failure of the fourth type which was repeated often occurred in a chordwise joggle in an external doubler plate near the wing attach angle. These failures appeared in three left wings and one right and are numbered 4, 10, 16, and 29. Failures were expected to occur at this point since the brittle-lacquer static test had indicated a high stress in this region. An example of this failure is shown in figure 16 after it had progressed to a considerable length.

Figure 15.- Failure inside right nacelle, span station 170.

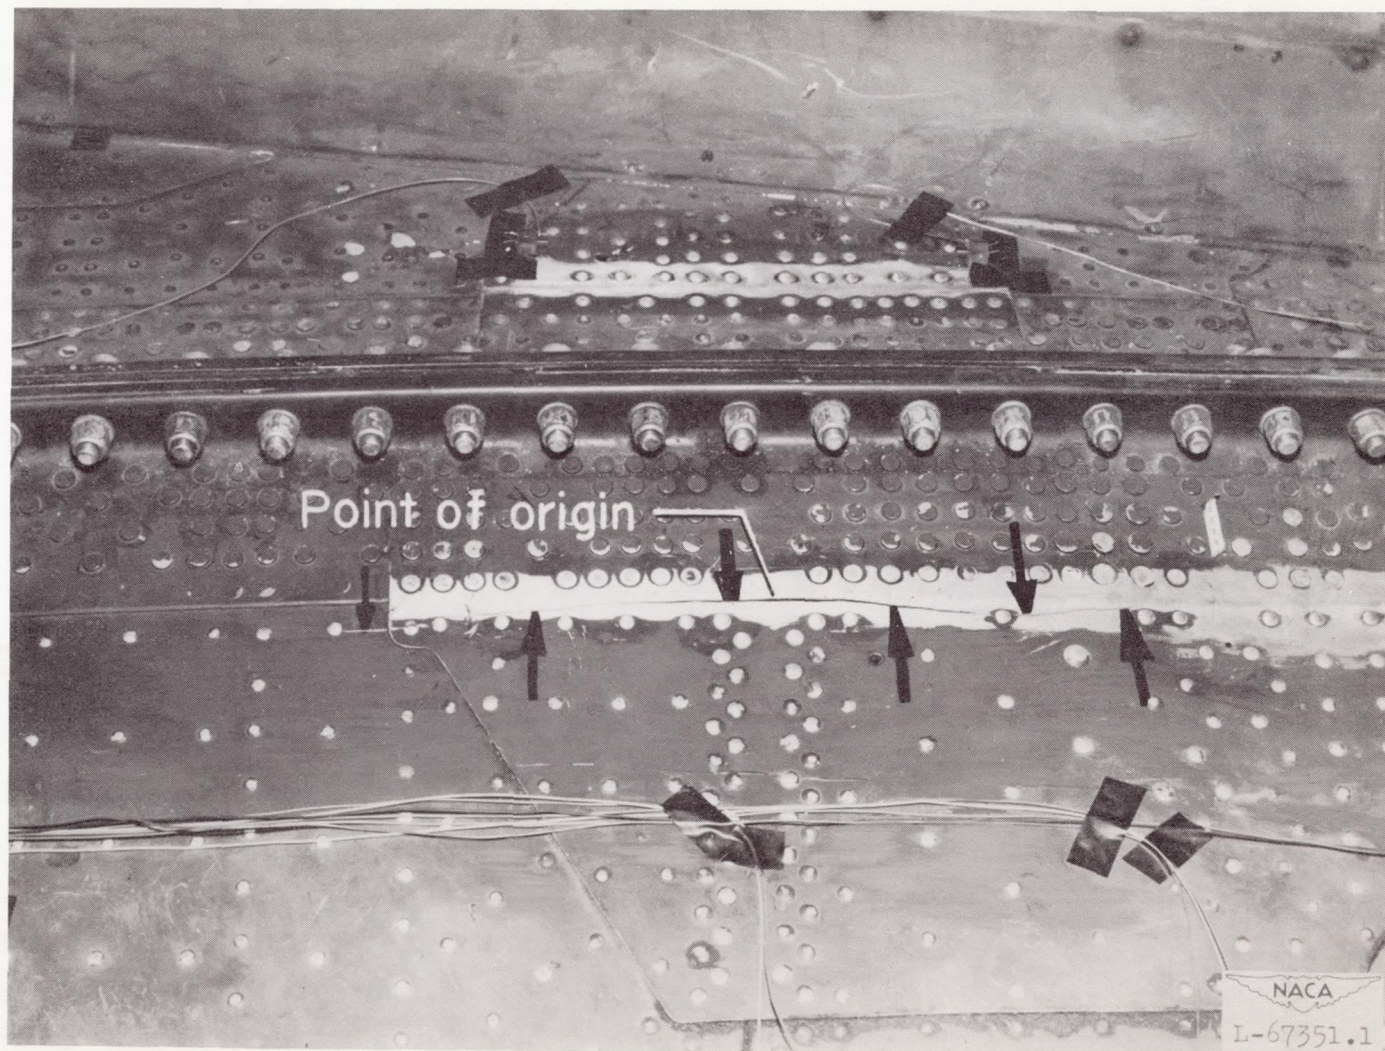
Figure 16.- Failure that initiated in a joggle of an external reinforcing doubler plate.

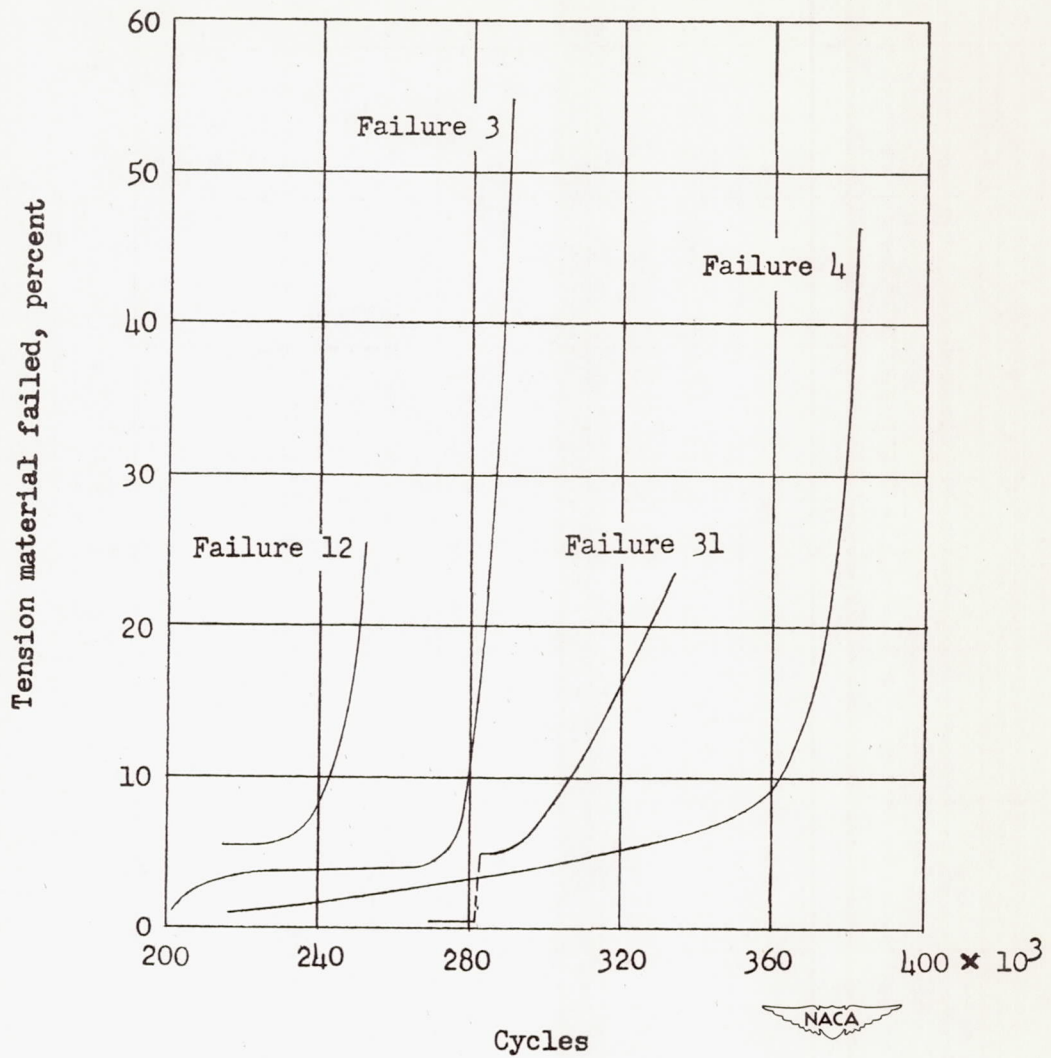
Several of the fatigue cracks in the wing outer panels were allowed to grow until a considerable amount of the tension surface had failed. The rate at which the cracks grew is shown in figure 18, in which the percent of cross-sectional material failed in the tension surface at the wing station where the failure occurred is plotted as a function of the number of cycles of load applied. The crack-growth curves of figure 18 indicate that the propagation of the cracks was relatively slow until about 5 to 9 percent of the tension material had failed. At this point the slopes of the curves abruptly become very steep and thereby indicate a rapid propagation of the crack thereafter. The abrupt discontinuity in

one of the curves (failure 31) was caused by the sudden failure of a large stiffener. In spite of this, the curve exhibits the same rapid increase in rate of crack growth between 5 and 9 percent failure of the tension material. It must be recognized, however, that this slow initial rate of crack growth does not preclude the possibility of a failure initiating undetected in a large stiffener or spar flange which in itself has a larger percentage of tension area than the 5 to 9 percent value mentioned. It is also probable that this percentage might depend to some extent on the stress level at the crack.

Figure 18.- Crack growth of several fatigue failures.

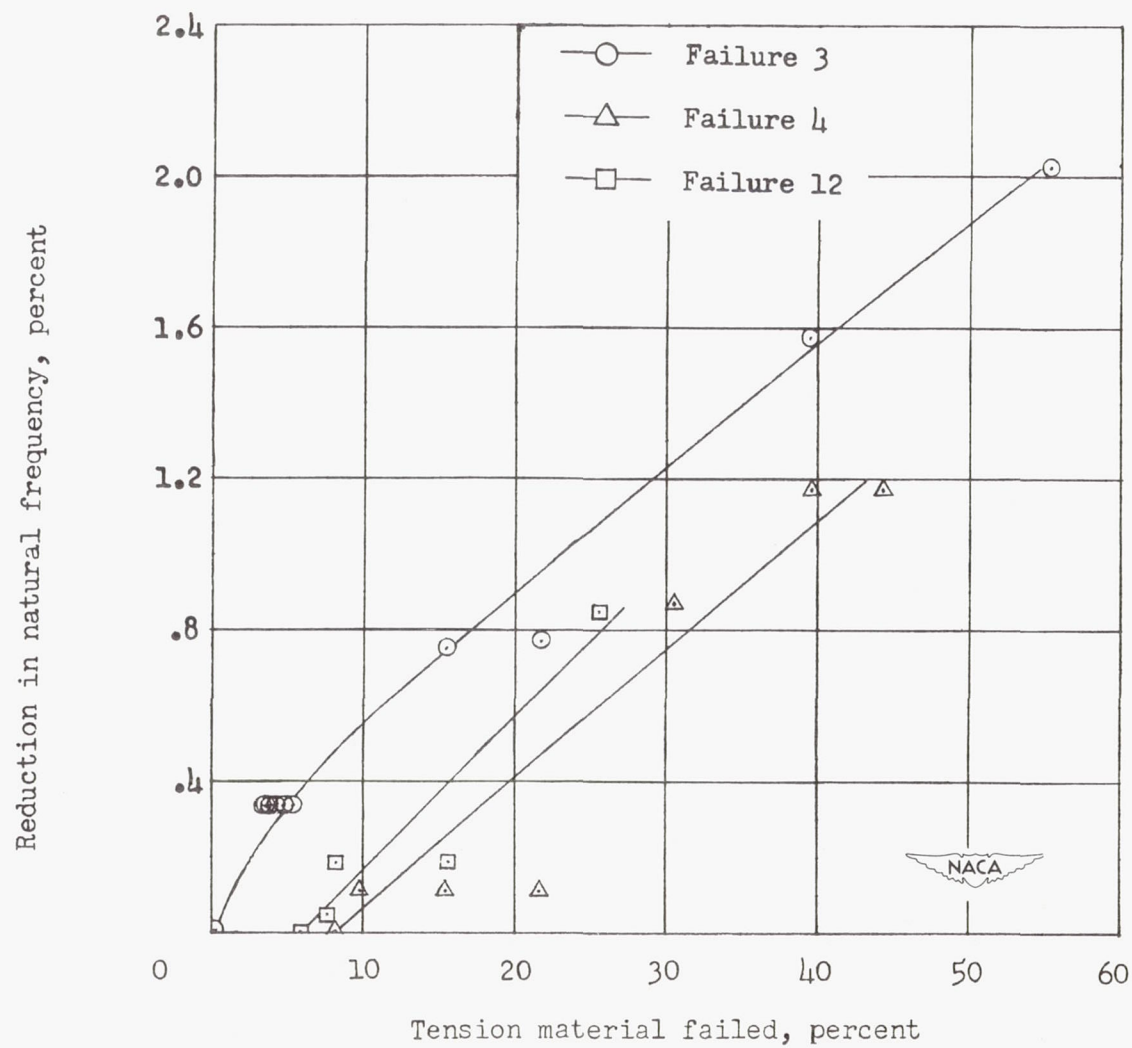
Figure 19.- Variation of natural frequency of test specimen with loss of tension material.

The tests indicated that the natural frequency of the test wings was not affected by fatigue damage until after a fatigue failure had originated. Even then, the change in natural frequency was very small and amounted to only about 2.0 percent with as much as 55 percent of the tension material failed in fatigue. In figure 19 the indicated change in natural frequency is plotted as a function of percent of tension material failed for several of the failures.
